2021 Long-Term Monitoring Data Summary Report

**St. Lawrence River Remediation Project
Long-Term Monitoring Program – Year 12**

December 2021

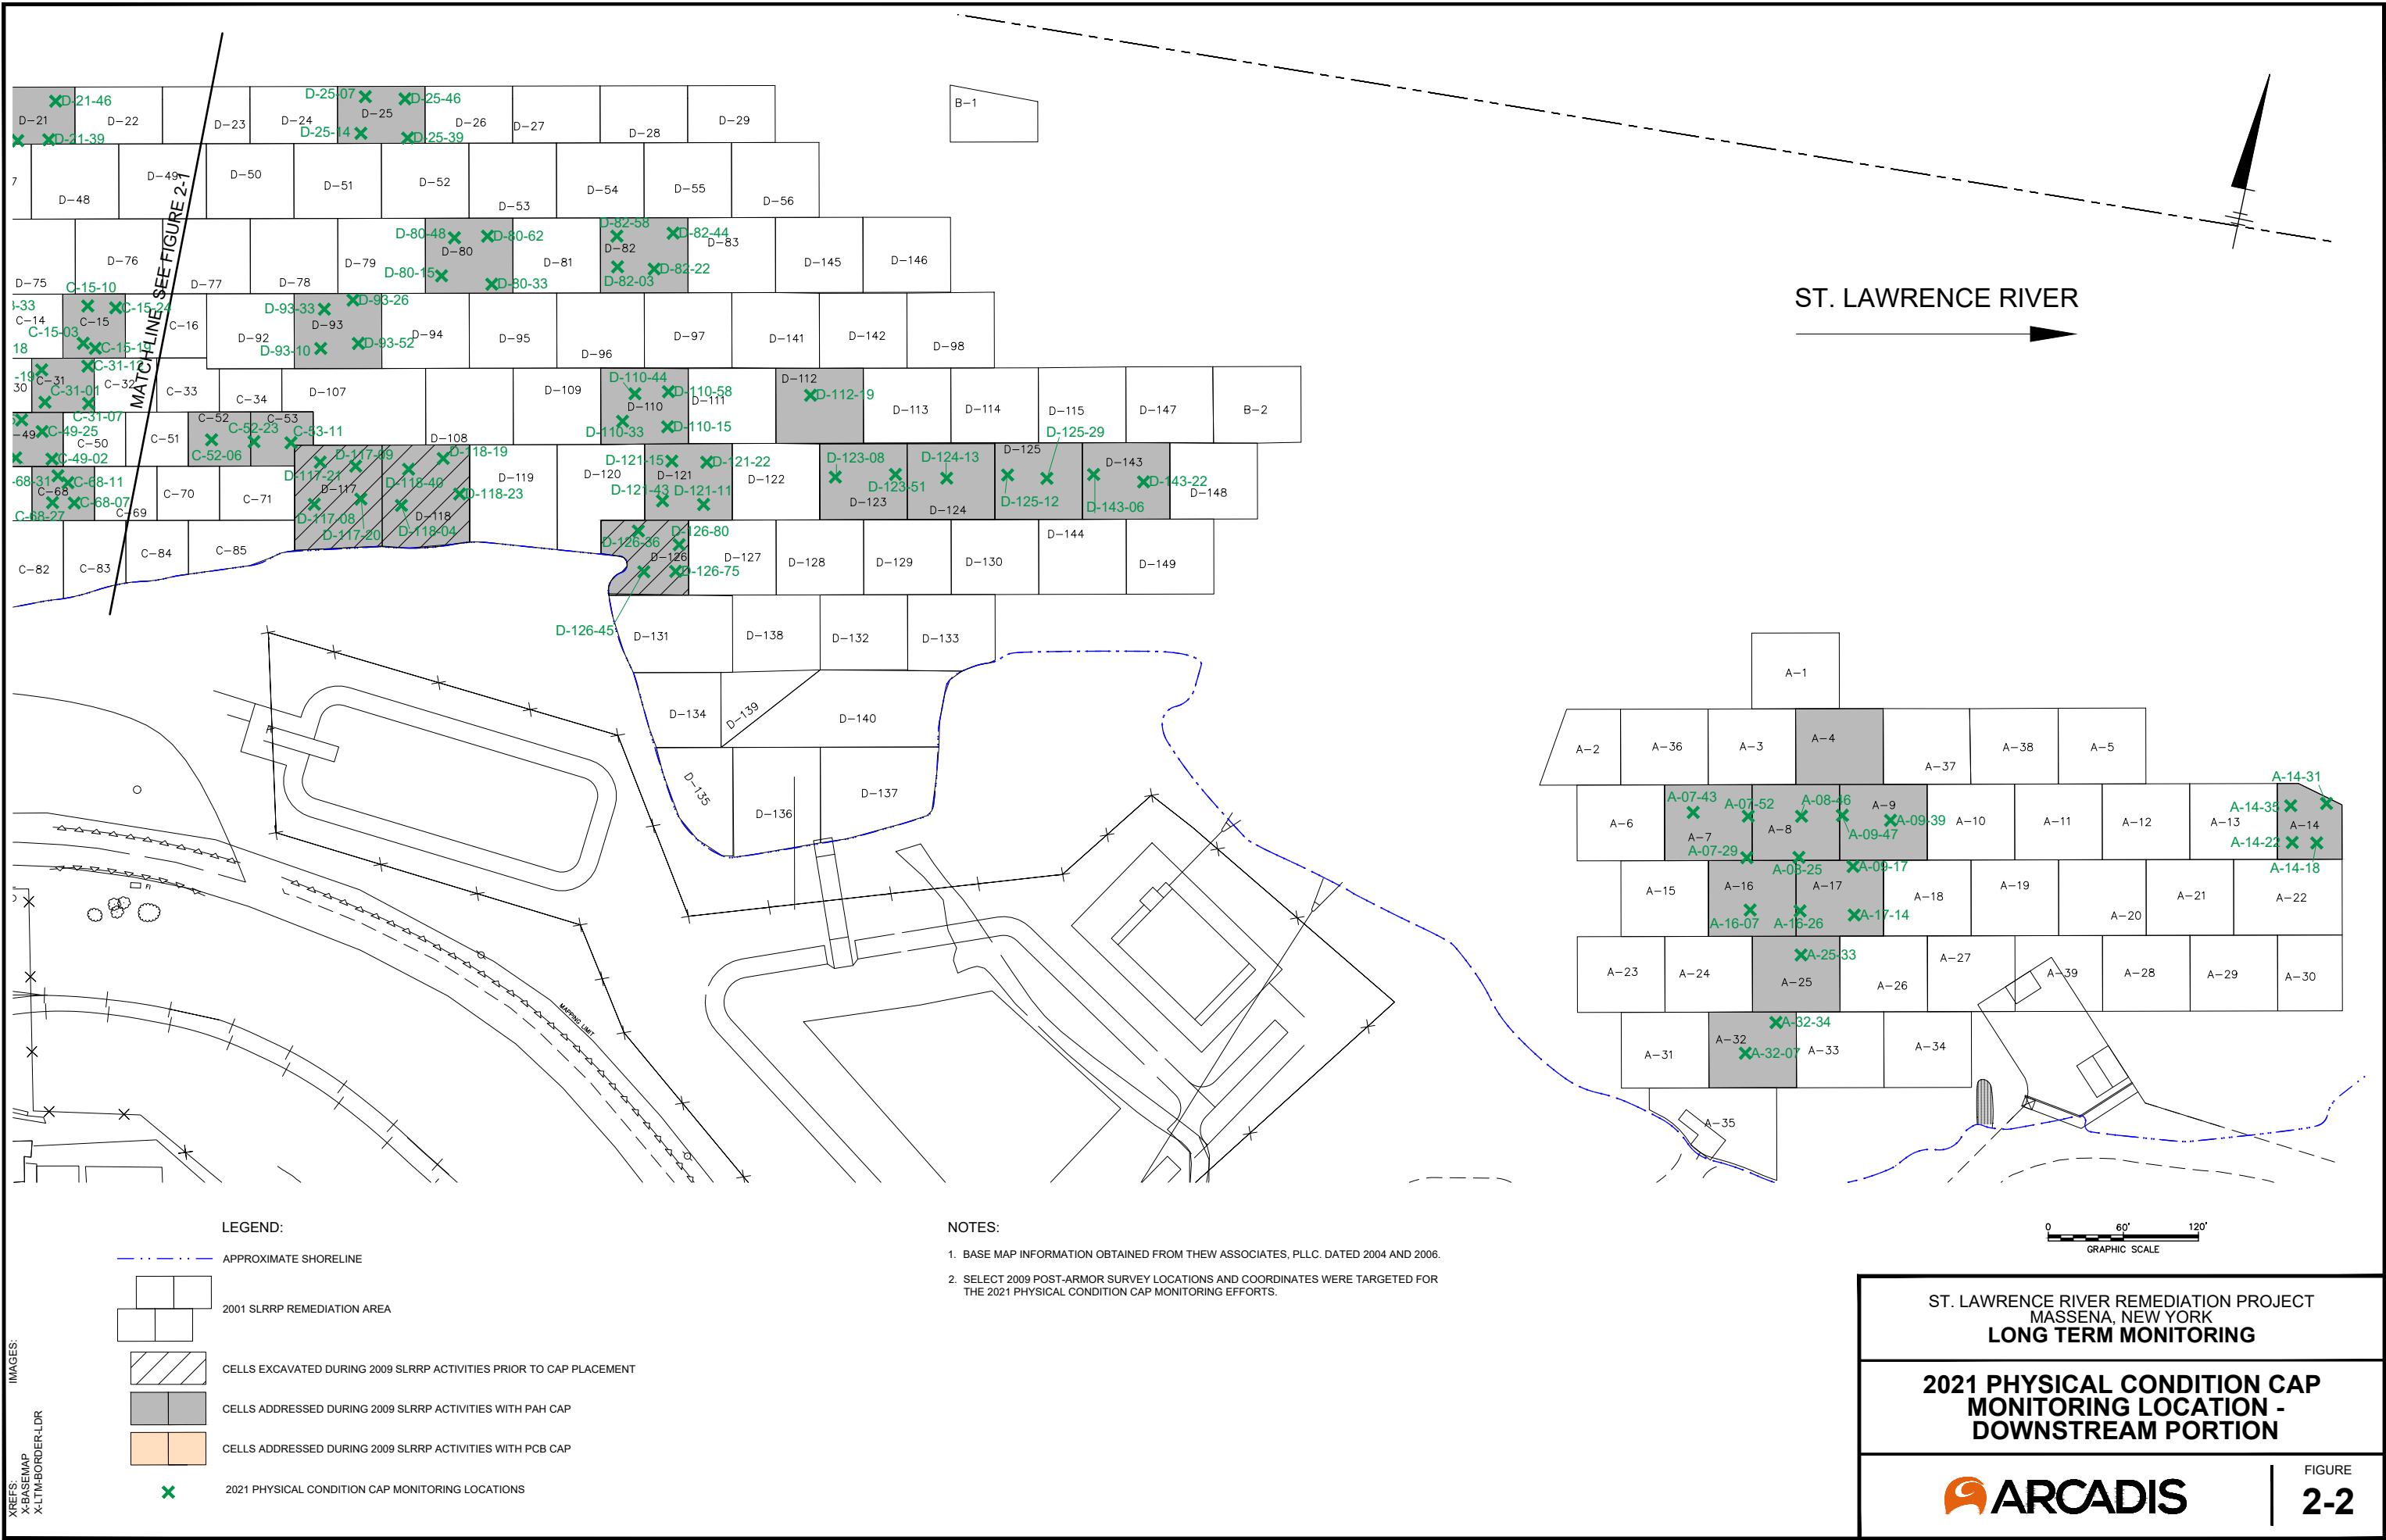
FIGURE
2-1

Manual probing was performed at a total of 151 locations spaced across the Site at approximately every 1,000 square feet for isolated capped cells and approximately every 2,500 square feet for contiguous capped cells (Figures 2-1 and 2-2). The targeted probing locations coincided with locations used during the 2009 construction verification program, and are the same locations monitored during each of the previous events. Manual probing was performed to document the presence of armor stone, habitat material, and/or other substrate covering the stone. Probing was conducted in accordance with the protocol described in the LTMP (Arcadis, August 2021). At each monitoring location, a graduated rod was used to penetrate the habitat material or other deposited material until refusal was met. Penetration depth was measured at each location using the probing rod gradations (0.1-foot intervals).

1. Coordinates are based on the North American Datum of 1983, New York East Zone, US Survey Foot.
2. Locations are shown on Figures 2-1 and 2-2.
3. Underwater video obtained from bolded locations. Video can be found in Appendix A.
